20 **UNITED STATES DISTRICT COURT**  
21 **NORTHERN DISTRICT OF CALIFORNIA**

27 Case No. 3:20-cv-7983

28 **COMPLAINT AND**  
**DEMAND FOR JURY TRIAL**

1 **II. The Defect in Tank 4**

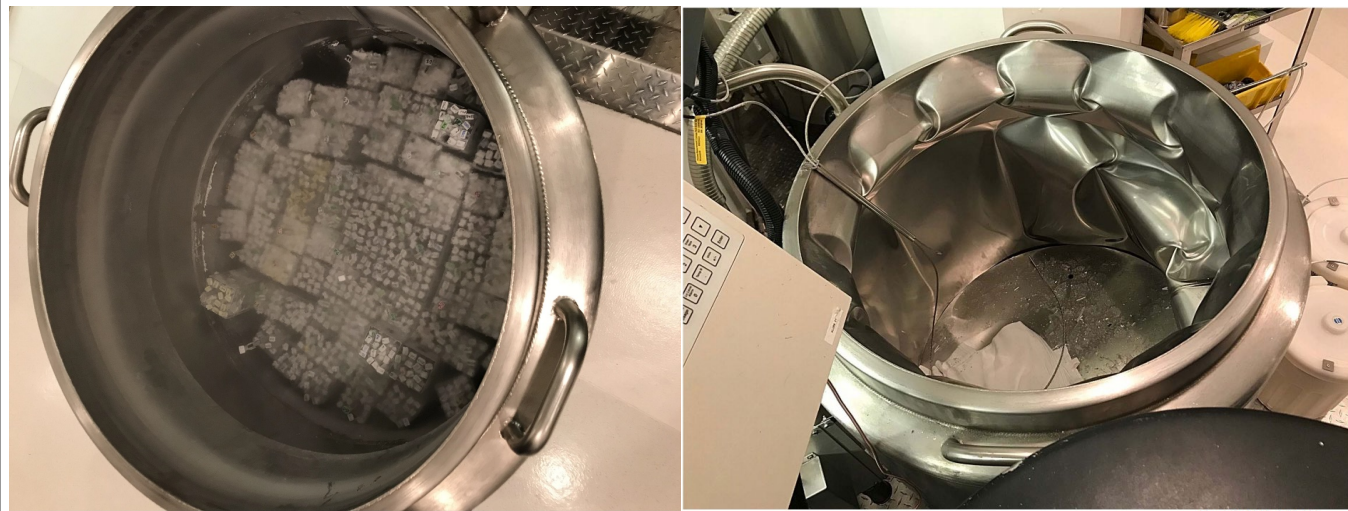
20 5. The cracked weld also triggered an implosion of the tank’s inner vessel, as the liquid  
21 nitrogen that was sucked into the vacuum space transitioned to gaseous nitrogen and exerted pressure  
22  
23  
24  
25  
26  
27  
28

1 on the inner vessel's walls. That is why the lid of the tank was difficult for PFC's embryologists to  
2 remove. The imploded tank is shown below, on the right:

3  
4  
5  
6  
7  
8  
9  
10  
11  
12 *Normal Tank*

*Imploded Tank*

13 6. This dramatic result is exactly what the tank's manufacturer, Defendant Chart Inc.,  
14 predicted would occur if the weld were to crack, but Chart has so far failed to take responsibility for the  
15 tank failure.

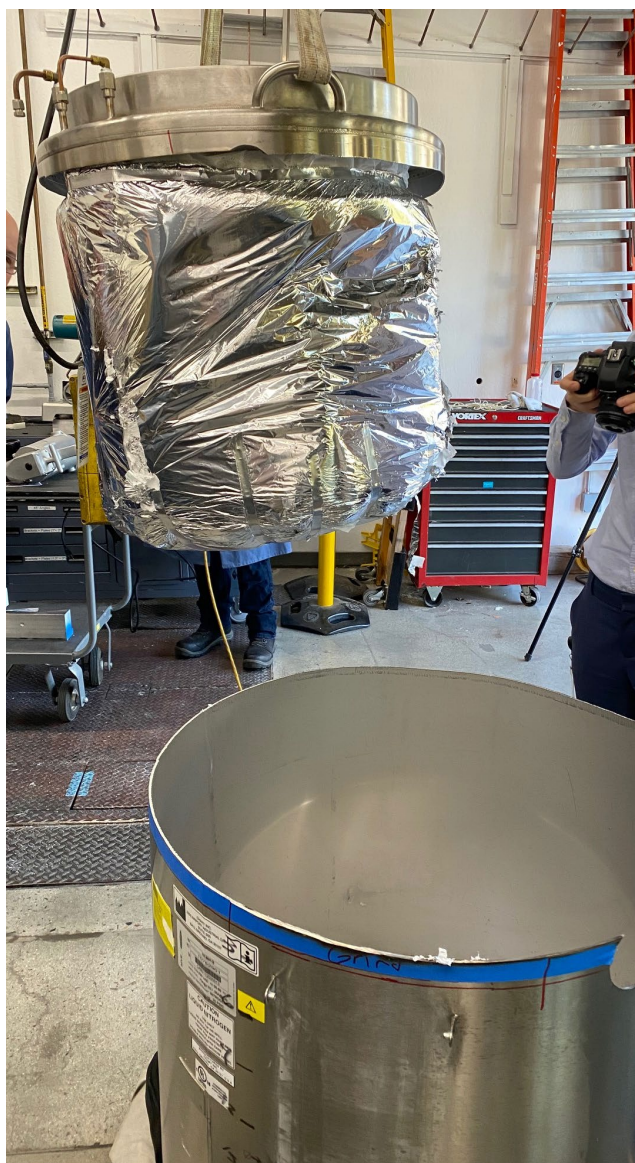
4 19. The picture below was taken following failure of Tank 4 and shows the tank's inner  
5 vessel (wrapped in reflective material) being removed from the outer vessel. In between the two vessels  
6 was an interstitial space. Before a tank is put into service, Chart draws a vacuum within that space by  
7 sealing it shut and pumping out the air. The resulting vacuum space is what allows cryopreservation  
8 tanks to keep liquid nitrogen and biological samples at  $-198^{\circ}\text{C}$ .

28 *Tank 4's inner vessel suspended after removal  
from outer vessel (vacuum space was in between)*

1           20.     Heat transfer occurs when molecules bump into other nearby molecules and transfer  
2 some of their energy. Because the tank’s vacuum space contains very few molecules, heat transfer from  
3 the outside environment to the tank’s inner vessel is minimal when the vacuum is intact. Some of the  
4 liquid nitrogen gradually warms above -198° C and evaporates, but only a small portion each day,  
5 which can be replenished by adding more liquid nitrogen. Without the vacuum space, however, the  
6 liquid nitrogen inside the tank quickly warms up, turns into a gas, and leaves the biological samples  
7 exposed.

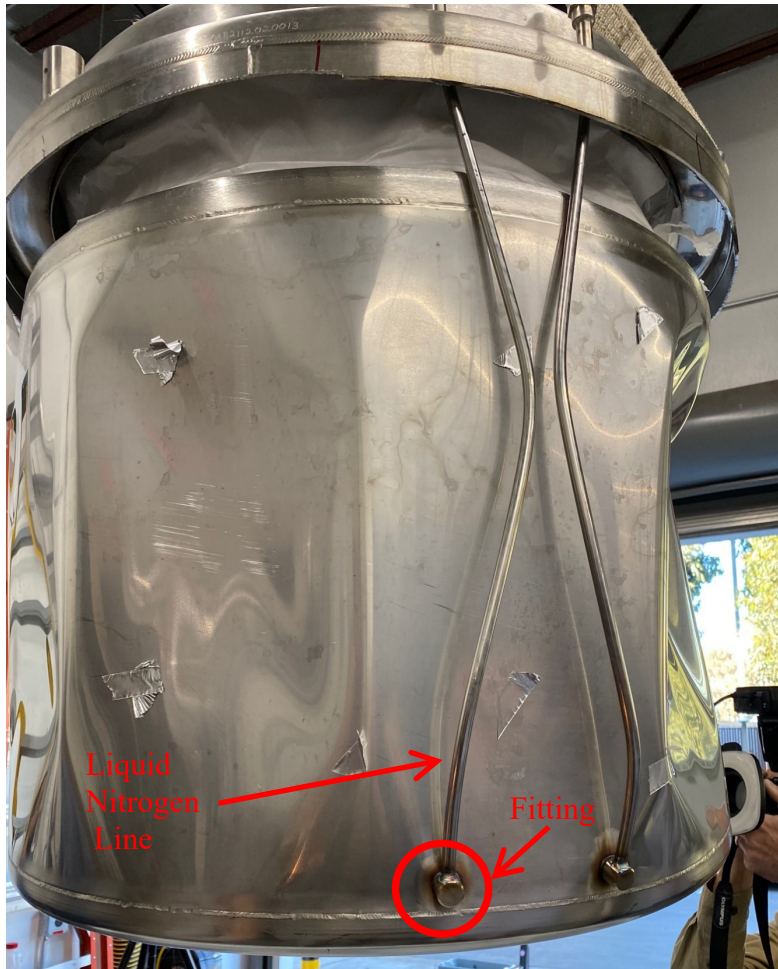
7 25. The picture below was taken after the outer vessel of Tank 4 was removed. The liquid  
8 nitrogen tube is on the left and the red circle shows where it connects to the inner vessel through a  
9 fitting.

*Liquid nitrogen tube feeds into Tank 4's inner vessel*

4 24. Tank 4 was manufactured with a metal tube that is used to refill the tank with liquid  
5 nitrogen. The tube ran from the top of the tank, down through the vacuum space between the inner and  
6 outer vessel, and then into the inner vessel near the bottom of the tank.

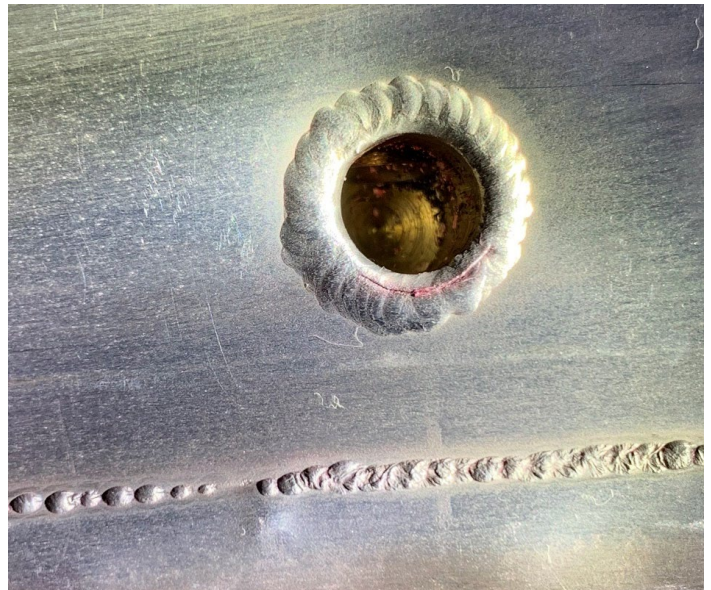
5           27.     The image on the right is the same weld, this time after using Magnaflux Spotcheck  
6 liquid dye penetrant. The fact the red dye penetrant remained after the surface was wiped clean is  
7 indicative of a crack.

21  
22  
23  
24  
25  
26  
27  
28  
*Red dye indicates a crack in the weld*

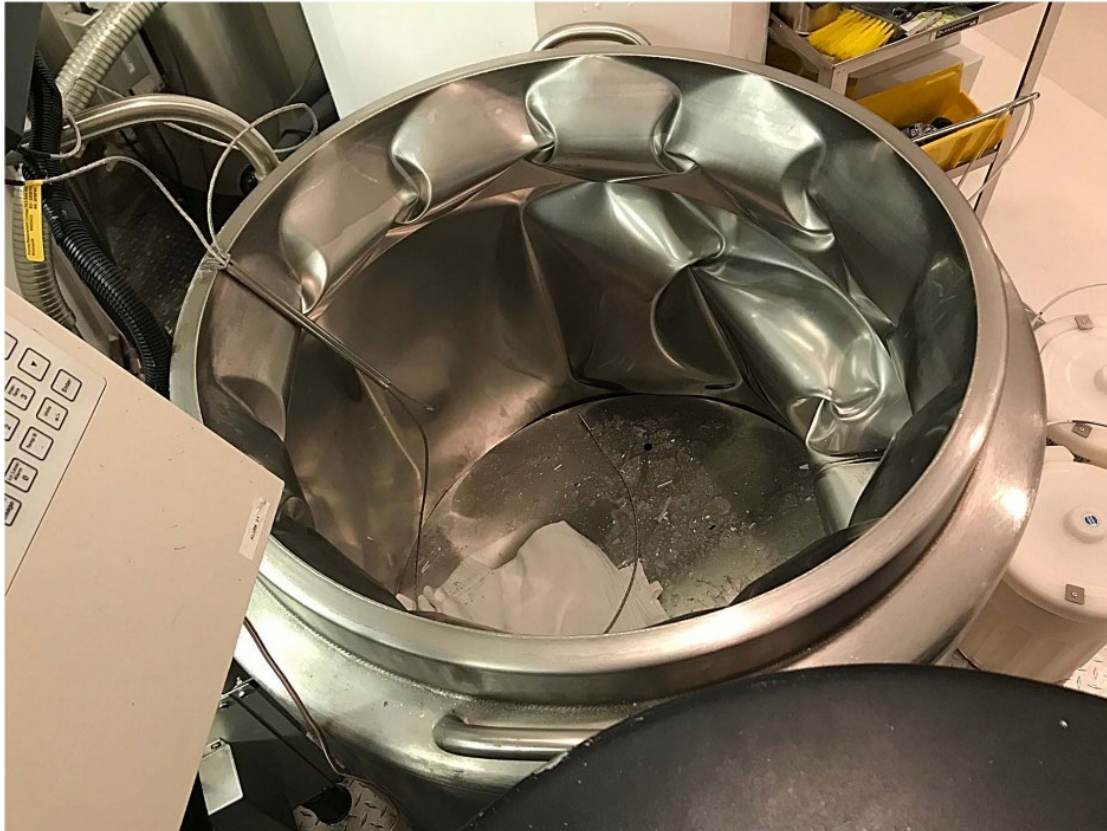
March 6, 2018, 9:03 AM

23           33.     The crack and accompanying leak of liquid nitrogen into the interstitial space both  
24 destroyed the vacuum insulation that allowed the inner vessel to stay cold and exerted significant  
25 pressure on the space between the tank's inner and outer vessel. The inner vessel gave way and  
26 crumpled. The following image was taken approximately 36 hours after the PFC embryologists  
27 discovered the Tank 4 failure and moved the affected eggs and embryos to another tank.

*Tank 4 after the incident*

34. This dramatically imploded tank is yet another indication of a cracked failure. As part of its compliance with the European Union’s Medical Device Directive, Chart was required to attempt to identify every way that its cryogenic freezers could theoretically fail. Representatives from Chart’s various departments came up with over a hundred potential failure modes. One of them was a cracked weld at the liquid nitrogen fill tube—exactly what expert analysis revealed happened to PFC’s Tank 4. If that weld did crack, Chart wrote that the result would be: “Liquid draws into vacuum space, expanding rapidly and causing an inner vessel implosion, total vacuum loss. Loss of function of the freezer.”
